**EFFECTS OF HIGH EMBANKMENT
CONSTRUCTION ON
ARCHAEOLOGICAL MATERIALS**

FINAL REPORT # FHWA/CA/TL-83/02

STATE OF CALIFORNIA
DEPARTMENT OF TRANSPORTATION
DIVISION OF CONSTRUCTION
OFFICE OF TRANSPORTATION LABORATORY

16. ABSTRACT This report presents a field study conducted by Caltrans to determine the effects of constructing a 75 foot high embankment over a simulated Native American artifact site on Interstate 15 north of San Diego. The study consisted of excavating two small test units and placing three layers of artifacts in each simulated excavation unit. Artifacts were placed and mapped in each of the two units by Caltrans archaeologists with observers from the Luiseno tribe. Both units were instrumented with soil pressure meters and settlement platforms. A 60-inch culvert pipe with a 72-inch "T" section was used to provide access for the retrieval of the artifacts. A vertical well was drilled into the access pipe at the "T" section to monitor the ground water. Soil pressure meters were also placed near an actual artifact site on an adjacent project which was to be covered under deep embankment of height similar to the test site. The results of this study supported the finding

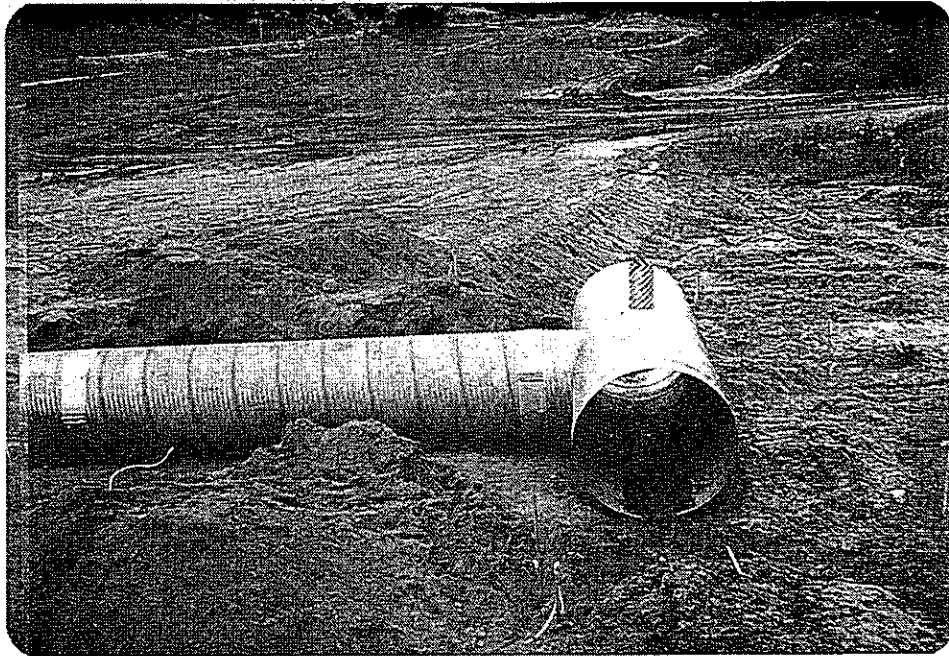
PHOTO 1 - Artifact Access Pipe

A 12-inch diameter section of CMP was attached to the top and in the center of the 72-inch diameter "T" section. The 12-inch CMP was brought up through the fill during construction to provide ventilation in the access tunnels (Photo 1).

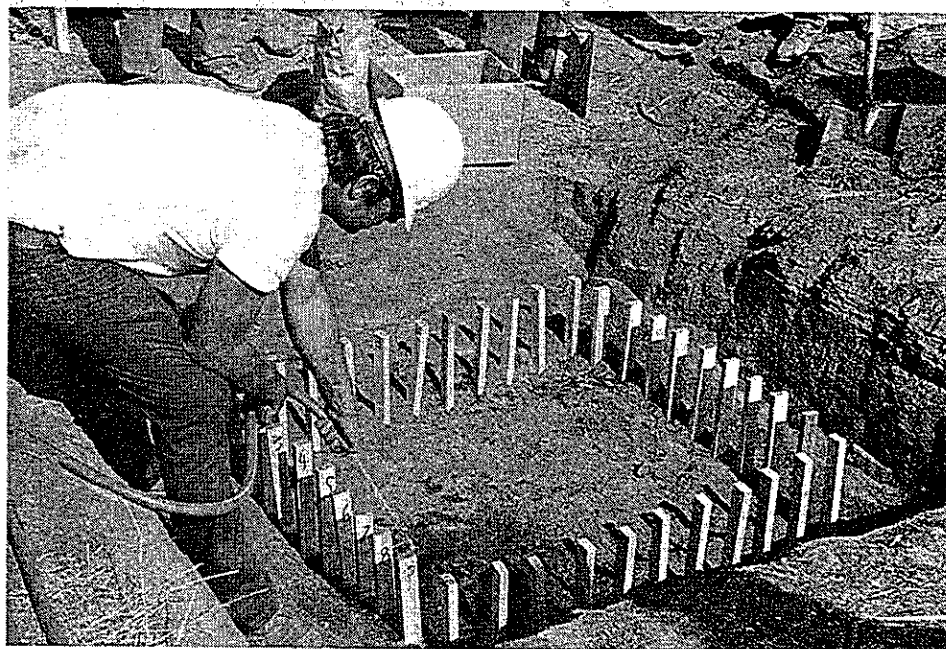
PHOTO 9 - Adding Water to the Midden
Soil to Insure Uniform Compaction

uniform compaction. The two units were completed in this fashion (Photos 8 and 9).

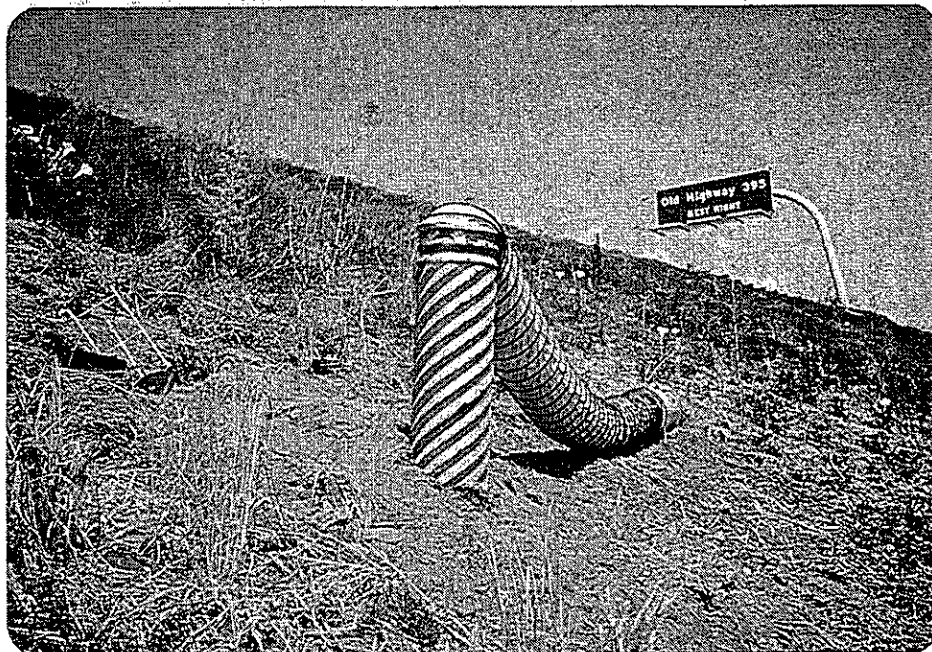
PHOTO 25 - Ventilation Pipe From Access Tunnel

The retrieval procedure was aided by lights hung along the 130 foot 60-inch pipe and into the "T" section to illuminate the work space. A photographic light bar was also used when additional light was needed for special close-up photography and fine work (Photo 24). Ventilation was provided by a 12-inch CMP running vertical from the access pipe to the surface which was placed during construction (Photo 25). A blower fan was attached to the pipe and was used continuously to allow better air circulation. In addition, a portable fan was used when the temperature and moisture content of the air became unbearable. A portable generator was used throughout the project to provide power for lights and ventilation. Due to equipment malfunctions and necessary maintenance, a significant amount of "down time" occurred with the generator.

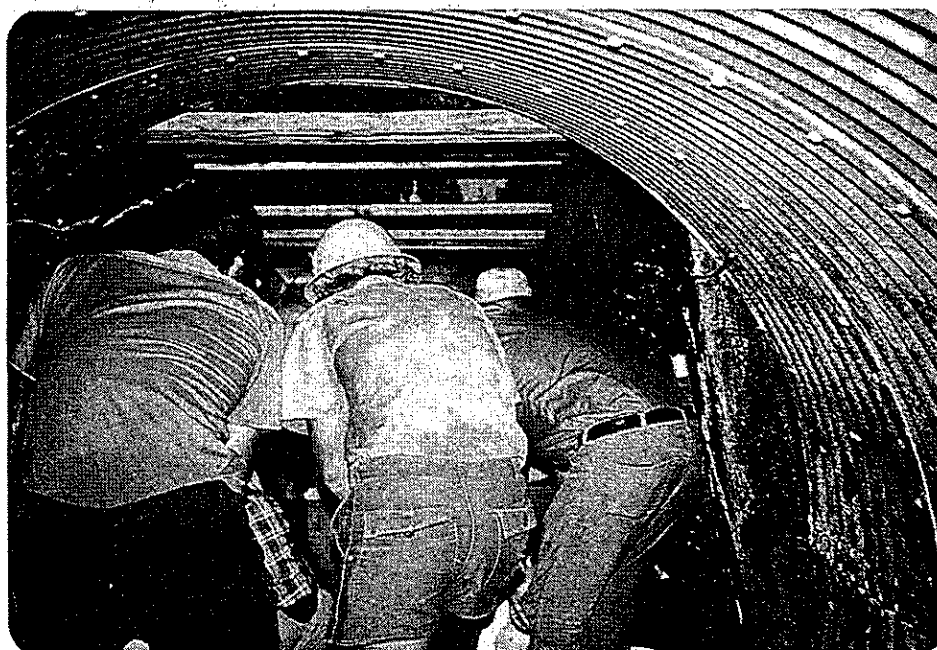
PHOTO 26 - Confined Working Space Inside Access Tunnel

The entire underground work area was considered a "confined space" (Photo 26). Consequently, special consideration was given to safety. Each day that any subsurface work was scheduled, pre-entry atmospheric testing took place. Tests were conducted to determine that (1) sufficient oxygen was present and (2) that gases (if present) were below a harmful level. In addition to atmospheric testing, the shoring was monitored with listening equipment to pick up and amplify subaudible noise generated by stress. No subaudible noise was detected during the monitoring periods.

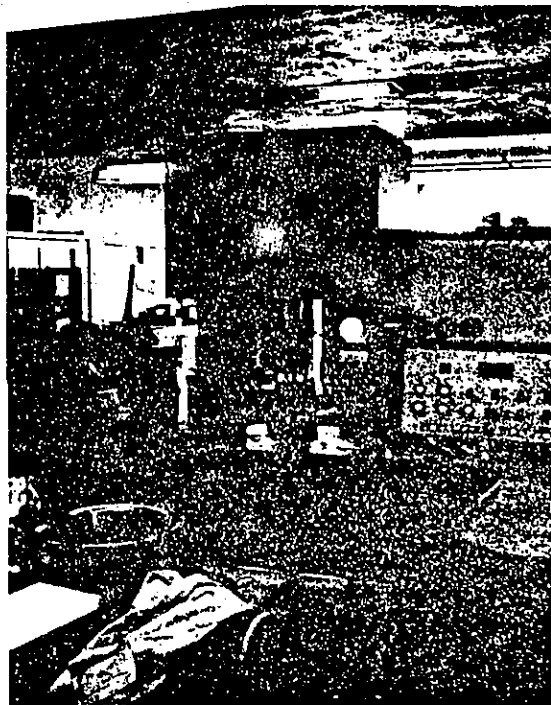
2. View of Cox Hydraulic Press used to compress midden soils to fill load equivalents.

Representative midden soils from the above sites and an assemblage of likely-to-be found artifacts (See figure 1) were loosely placed in a 6" diameter by 8" tall cylindrical mold. These mixtures were then hydraulically loaded to 1932 lbs. (68.3 psi), a load equivalent to the maximum fill height to be placed on any one site: 74 feet with an assumed density of 133 pcf.

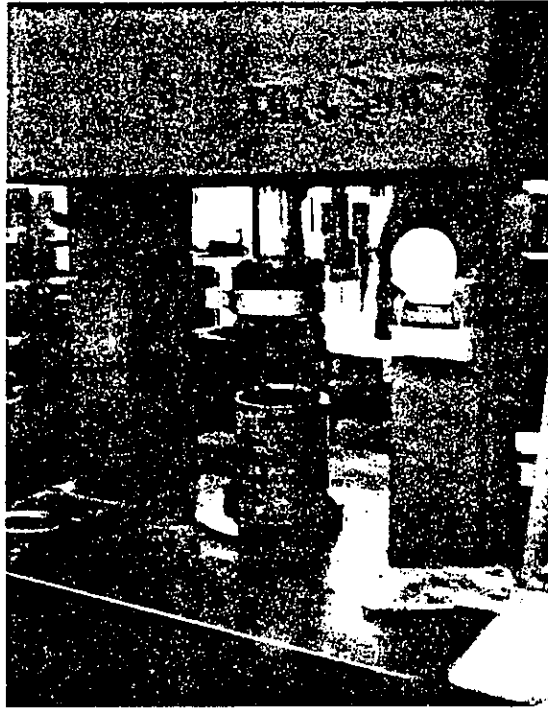
3. Close-up of Compression Cylinder loaded with midden soil and artifacts.
